High Temperature Chemistry in the Columbia Accident Investigation

Initial estimates on the temperature and conditions of the breach in Columbia's wing focused on analyses of the slag deposits. These deposits are complex mixtures of the reinforced carbon/carbon (RCC) constituents, insulation material, and wing structural materials. However it was possible to clearly discern melted/solidified Cerachrome® insulation, indicating the temperatures had exceeded 1760°C. Current research focuses on the carbon/carbon in the path from the breach. Carbon morphology indicates heavy oxidation and erosion. Raman spectroscopy yielded further temperature estimates. A technique developed at Sandia National Laboratories is based on crystallite size in carbon chars. Lower temperatures yield nanocrystalline graphite; whereas higher temperatures yield larger graphite crystals. By comparison to standards the temperatures on the recovered RCC fragments were estimated to have been greater than 2700°C.

— ACCIDENT HISTORY, WHAT CAUSED BREACH

- Objectives: reinforced carbon/carbon
OV-107 leading edge
 - Examine (RCC) near breach and hot-gas-path
 - Understand response of RCC to extreme conditions
 - Estima

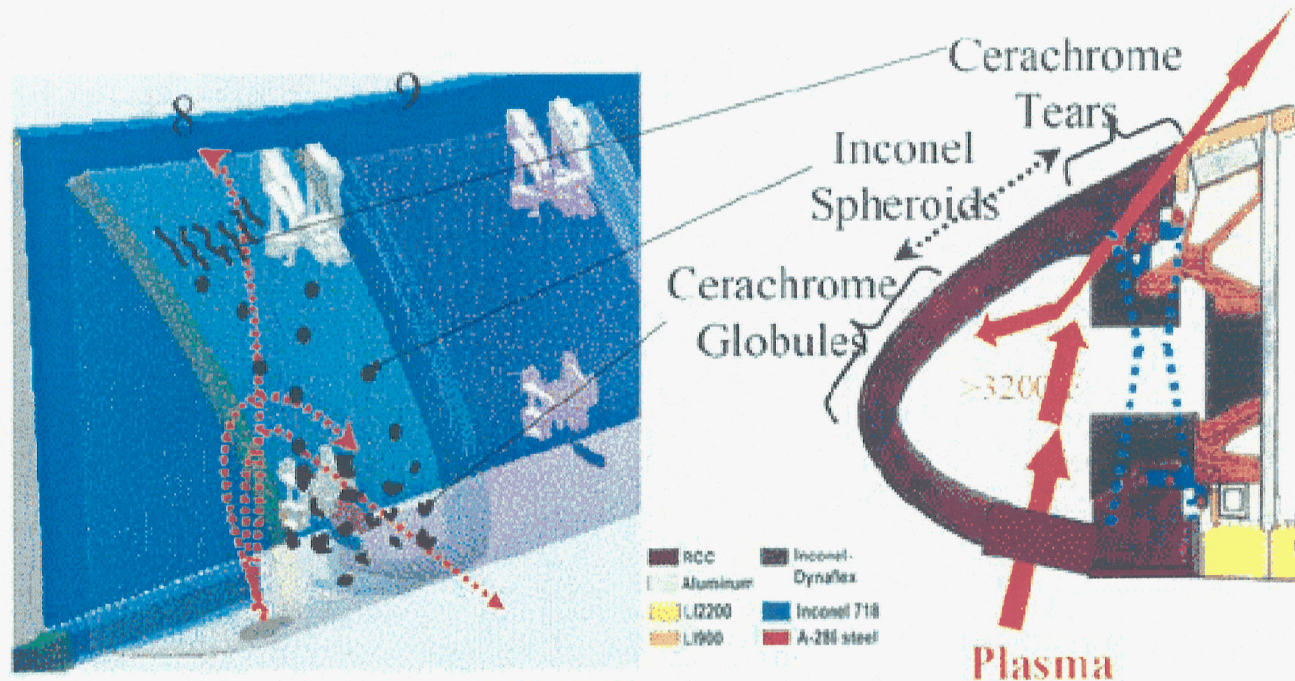
Identification of Breach

- Multi-NASA Center Team Effort—JSC, MSFC, LaRC, GRC
- Key features of recovered leading edge RCC
 - Large deposits of 'slag'—solidified Cerachrome insulation, aluminum alloys, Fe alloys, Ni alloys — *on backside*
 - 'Knife edge' appearance of RCC (reinforced carbon/carbon)—known to occur when an exposed edge of RCC is heavily oxidized

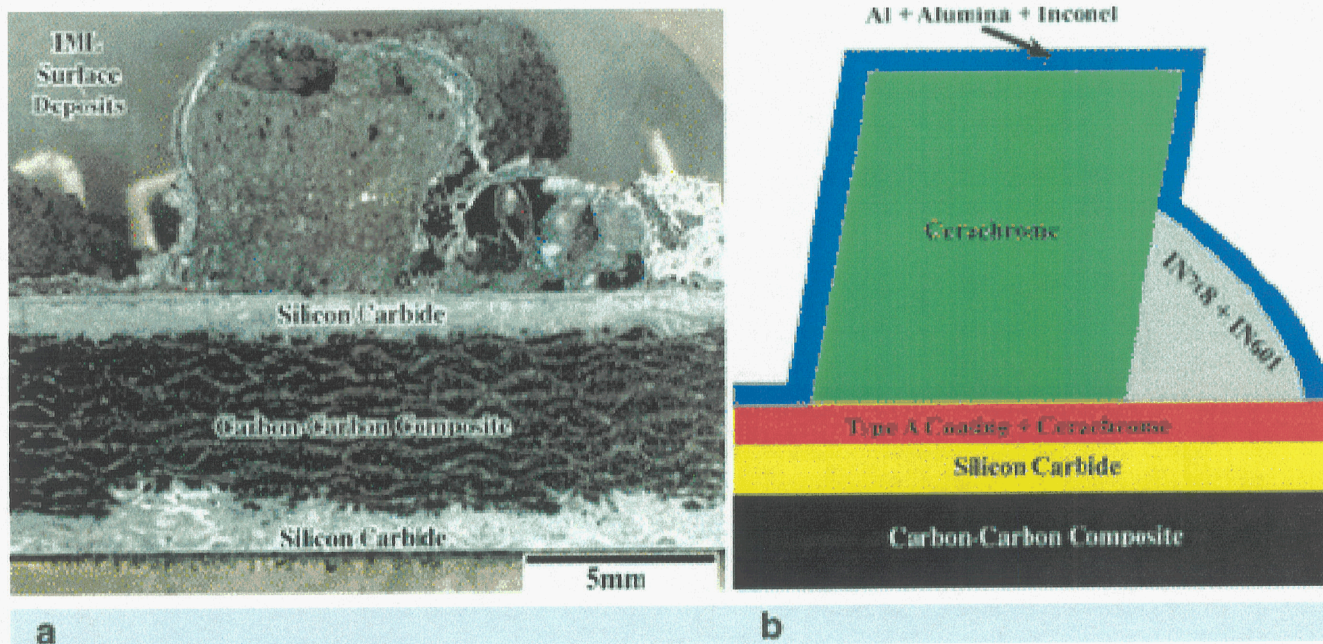
Previous Temperature Estimates

- Cerachrome® mp 1760°C—95% aluminosilicate; 3% chromia
- Mullite forms at ~1100°C
- Examination slag deposits from upper portion of Panel 8 identified mullite and melted Cerachrome \Rightarrow 1760°C or greater

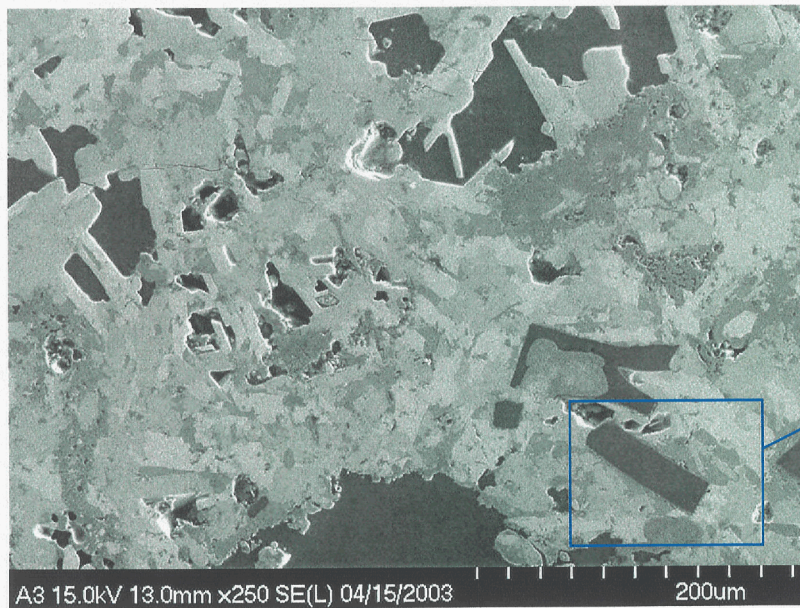
Slag Deposits—Complex Mixtures of Wing Constituents

Solidified metals and
ceramics

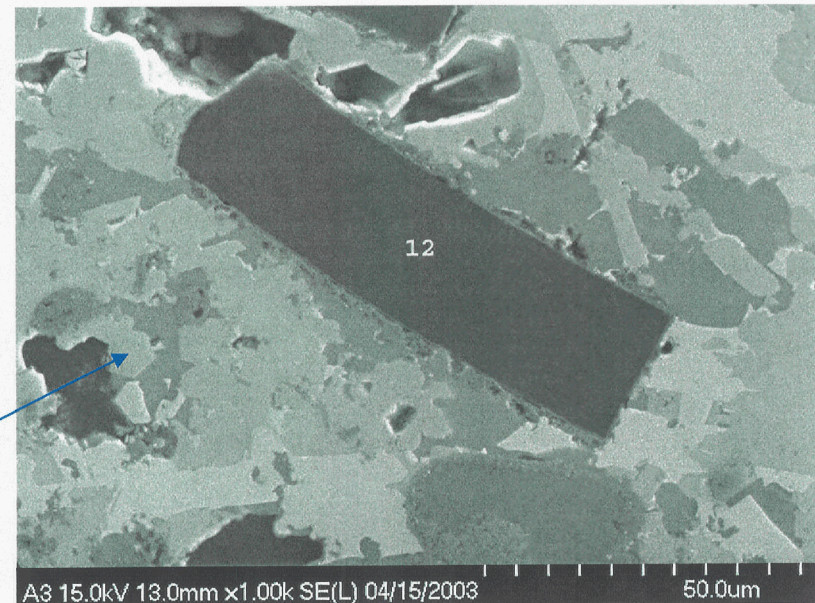
Region 12 – portion of
carbon fiber

Region of Melted Cerachrome

Only well-understood Feature for Temperature Determination

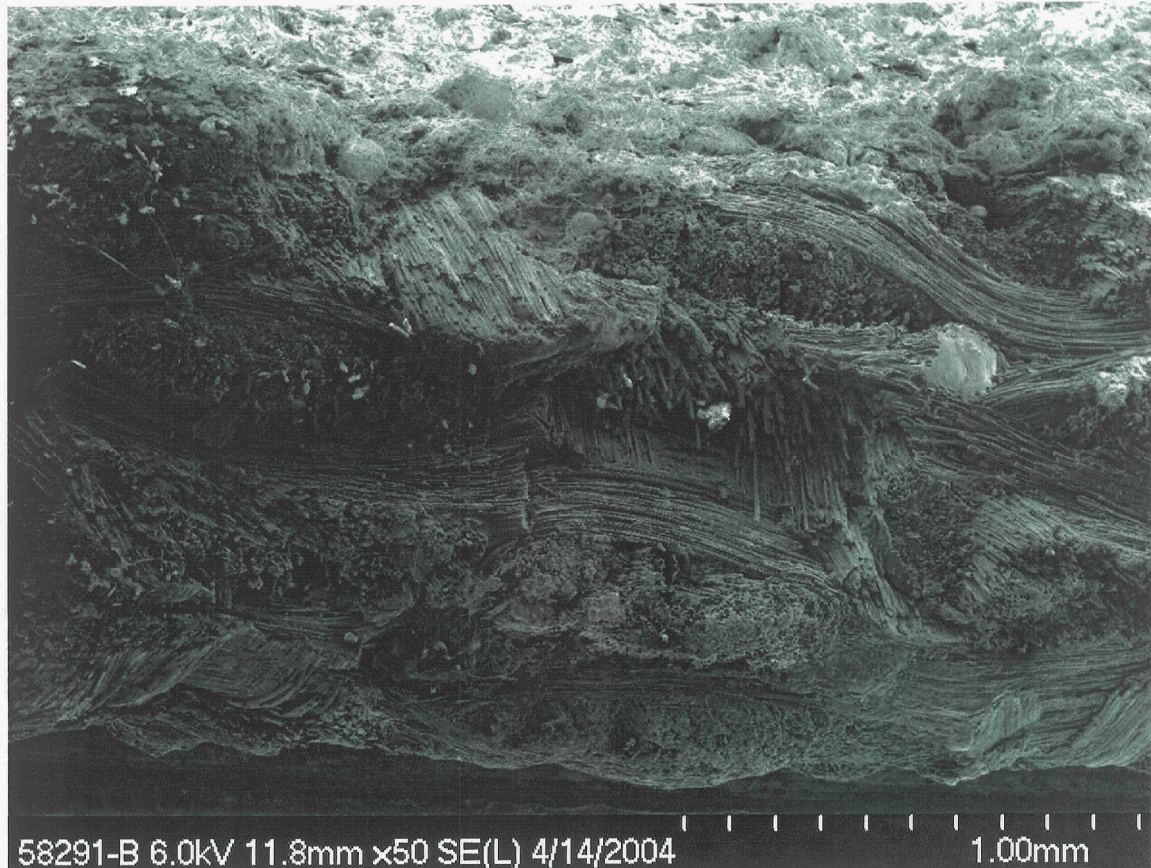
Typical Appearance of RCC Cross Section Fragment

Inner mold line

Slag—solidified
insulation (Cerachrome)
and metals

**Fractured/oxidized carbon
fibers and matrix—Focus
of this study**

Outer mold line

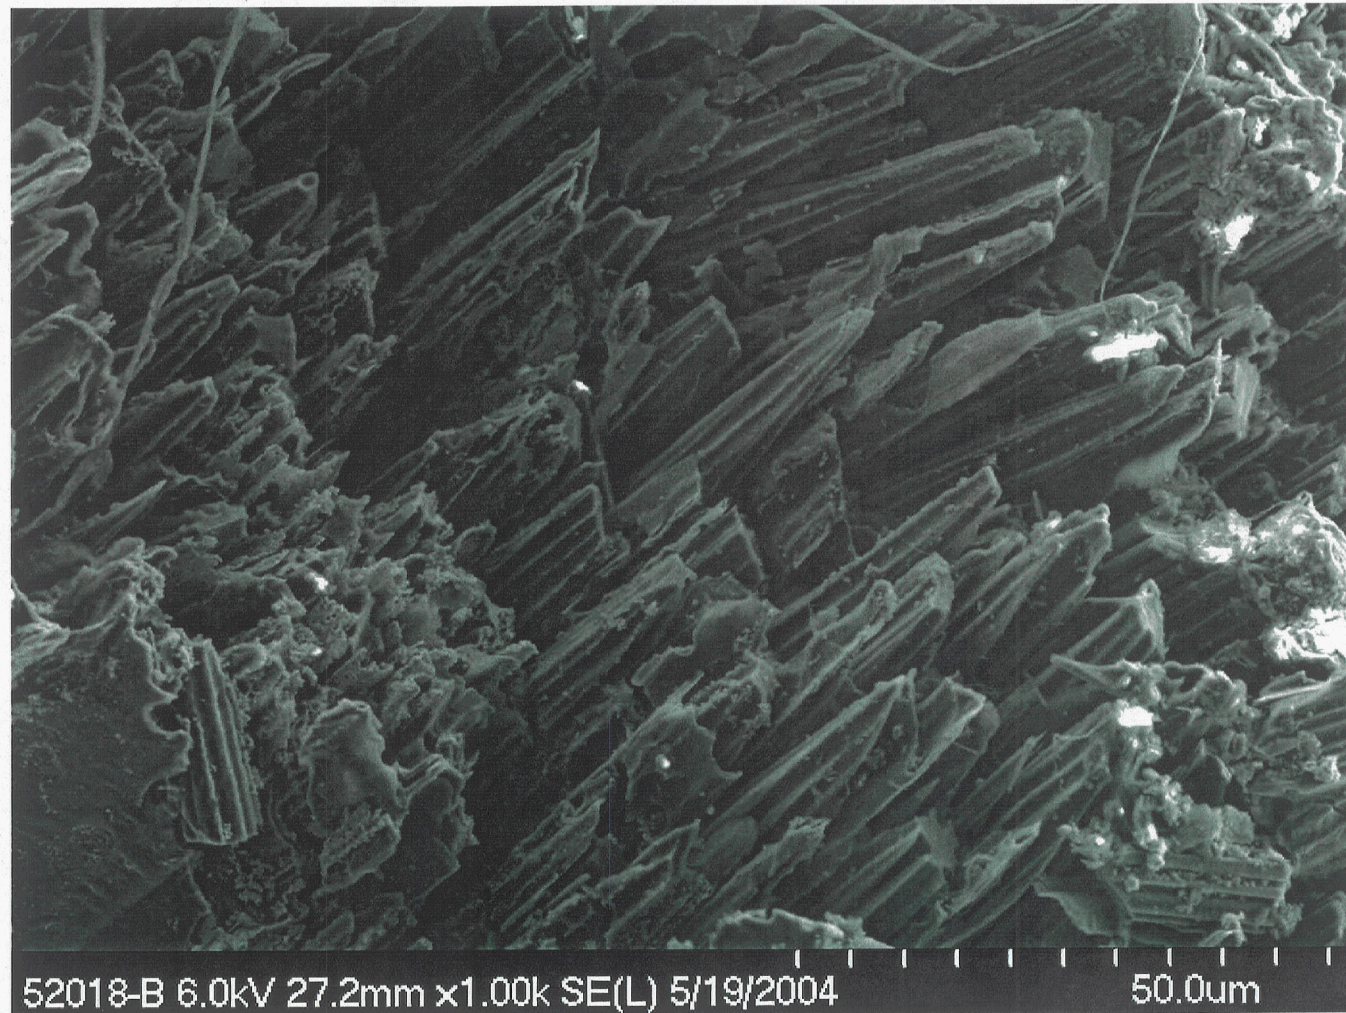
Panel 8--Lower

Characteristic Pointed Fibers from High Temperature Oxidation

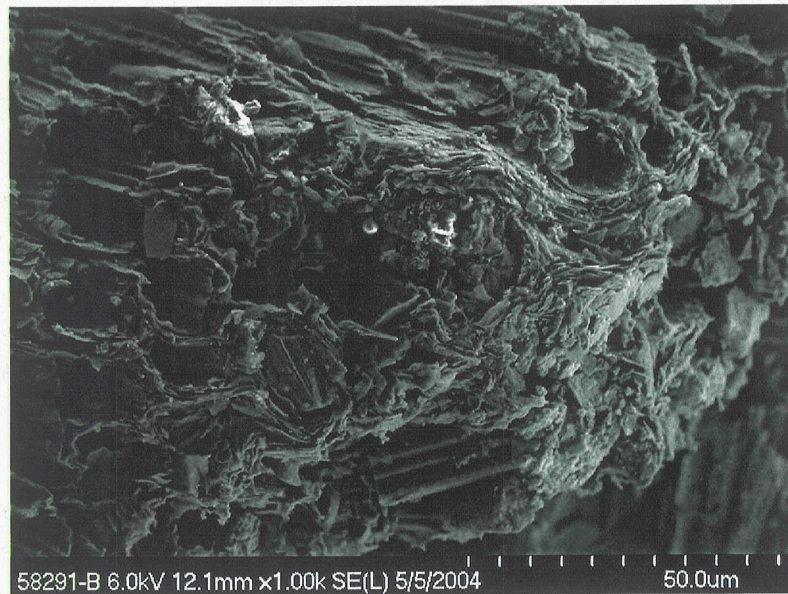
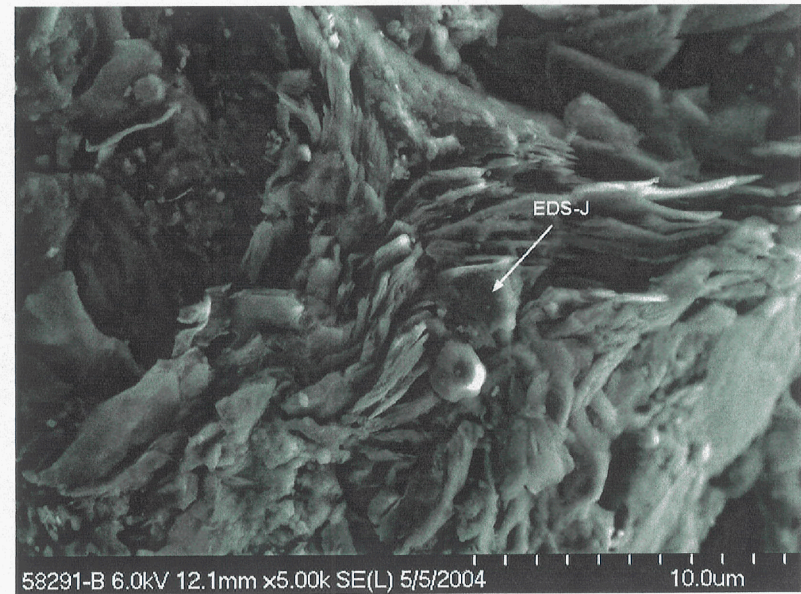
Panel 8

Extensive Oxidation and Erosion of Fibers and Matrix

Panel 8—This layered, plate-like structure is characteristic of heavy erosion in Carbon

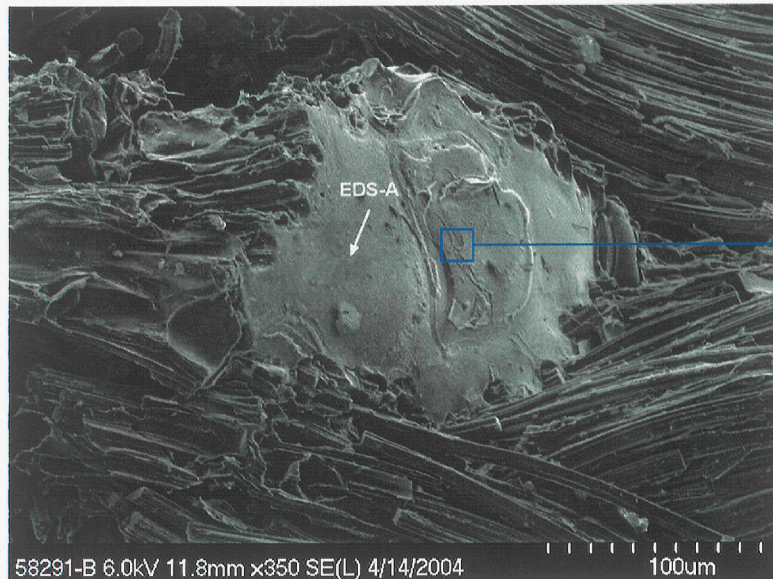
Unusual Features in Carbon Matrix

Flowing Carbon? Melting Point of Carbon is 3500 K

Overall View

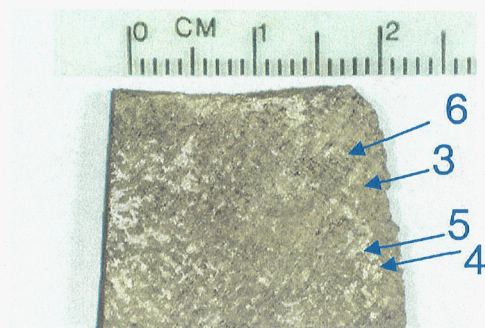
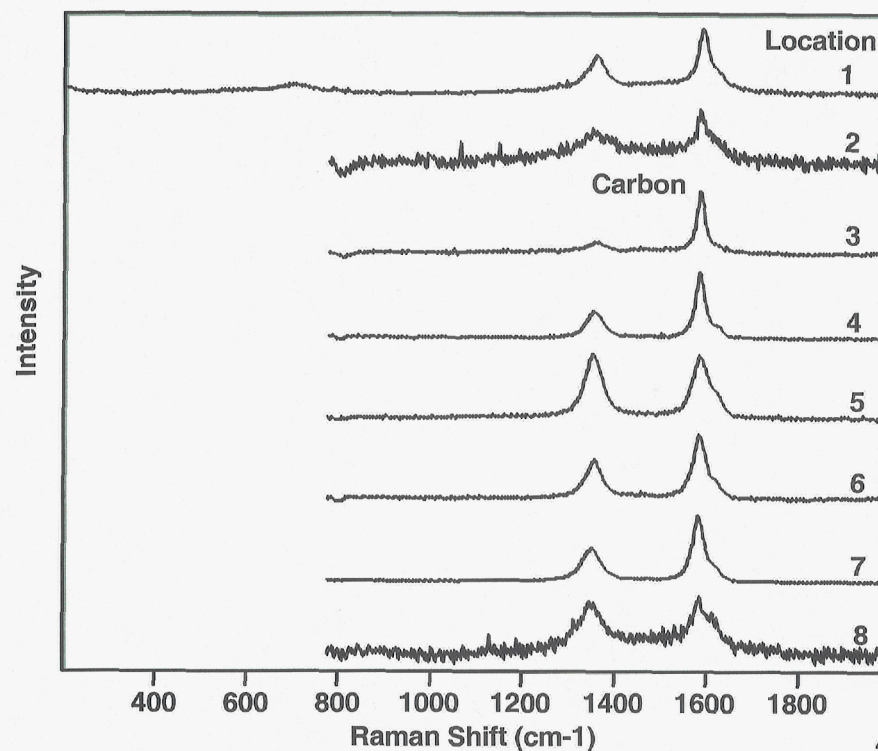
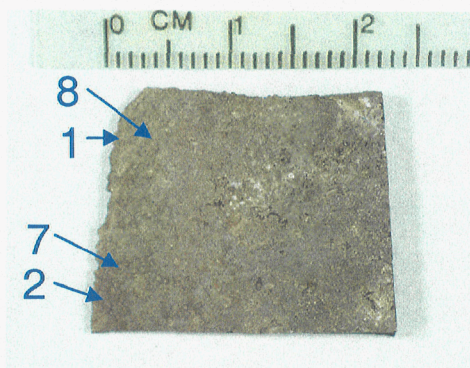
Item #49619A

Raman Analyses of Portion of Upper Panel 8, near Breach

Location	Location Description	Summary of Identified Bands
1	Knife edge	2700 C carbon plus small amount of low temp carbon
2	Knife edge	2700 C carbon plus small amount of low temp carbon
3	Knife edge	>> 2700 C carbon (off scale of reference carbons)
4	Knife edge	> 2700 C carbon (off scale of reference carbons)
5	Up slope	2400 C carbon
6	Up slope	2700 C carbon
7	Up slope	> 2700 C carbon (off scale of reference carbons)
8	Up slope	2400 C carbon
